# Operating Experience Weekly Summary 98-01

*January 2 through January 8, 1998*

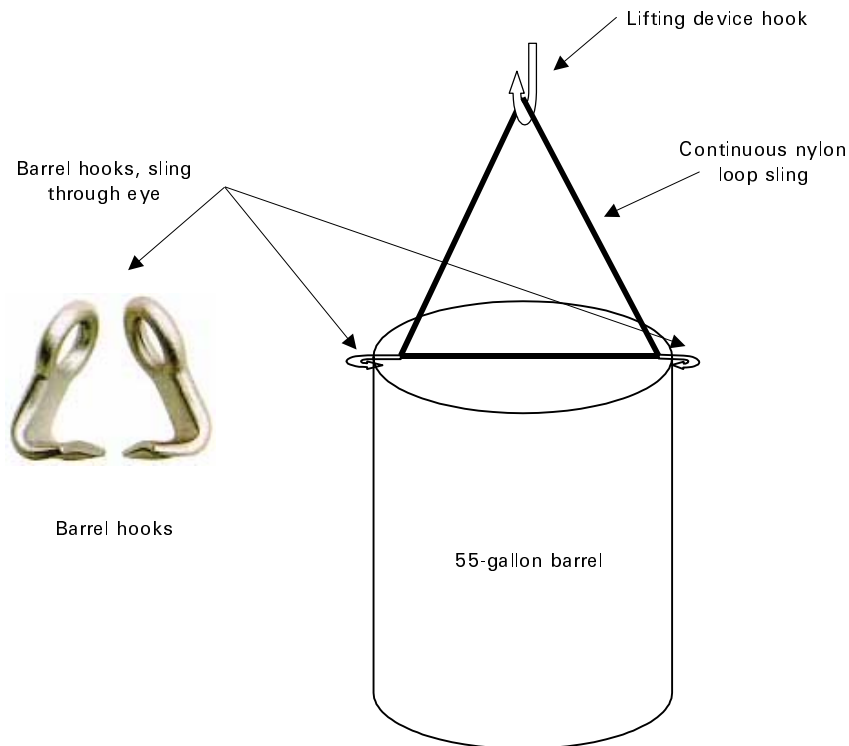
**Figure 2-1. Drum Sling Rigging Arrangement**

During a critique for the December 18 event, investigators determined that, as the drum was being lowered, the free end of the hoisting chain caught on the drum lid closure ring bolt. The free end of the hoisting chain was moving upward, relieving the load on one of the barrel hooks of the lifting sling. The drum began to tilt, and the rigging disengaged from the drum. Investigators determined that the hoist was not equipped with a chain bucket. This would have prevented the free end of the hoist chain from coming in contact with the load, but procedures did not require a chain bucket for this operation. Investigators also determined that neither the operator nor the spotter was in continual visual contact with the load as required by applicable procedures.

During a critique for the November 25 event, investigators determined that, when riggers lowered the drum, it caught on an adjacent drum on the truck bed and momentarily relieved the load on one of the barrel hooks of the lifting sling. The hook disengaged from the drum lid closure ring, and the drum dropped to the trailer bed surface. The rigger was injured when he fell to the pavement as he attempted to jump back from the falling drum. Figure 2-1 shows the rigging arrangement used for both occurrences.
